Appendix A Existing Conditions Inventory

EXISTING CONDITIONS INVENTORY

Riverside Marketplace District Vision Plan

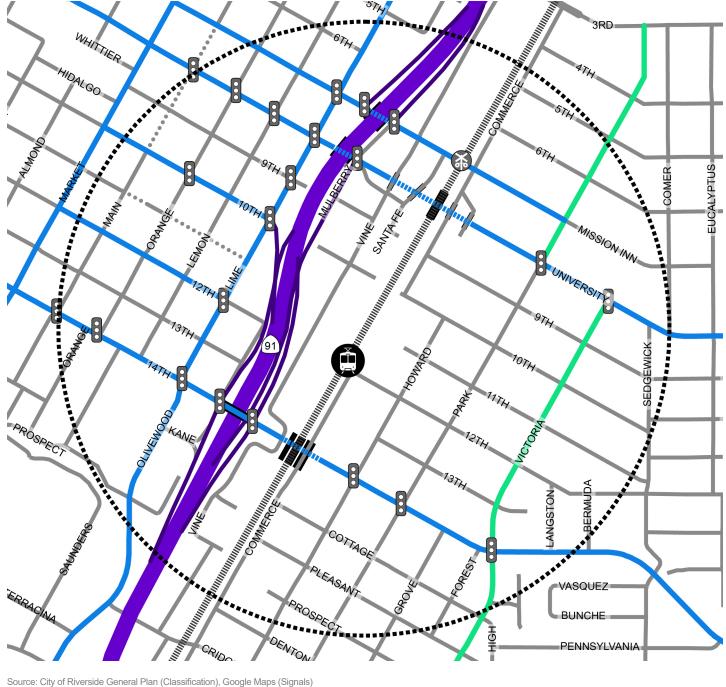
Access and Barriers

SR-91 on- / off- ramp Vehicle Access

- 14th
- Mission Inn
- 10th Street (on-ramp)

SR-91 Crossings

- Mission Inn
- University
- 14th

Metrolink Corridor Crossings

- Metrolink station pedestrian bridge
- Mission Inn

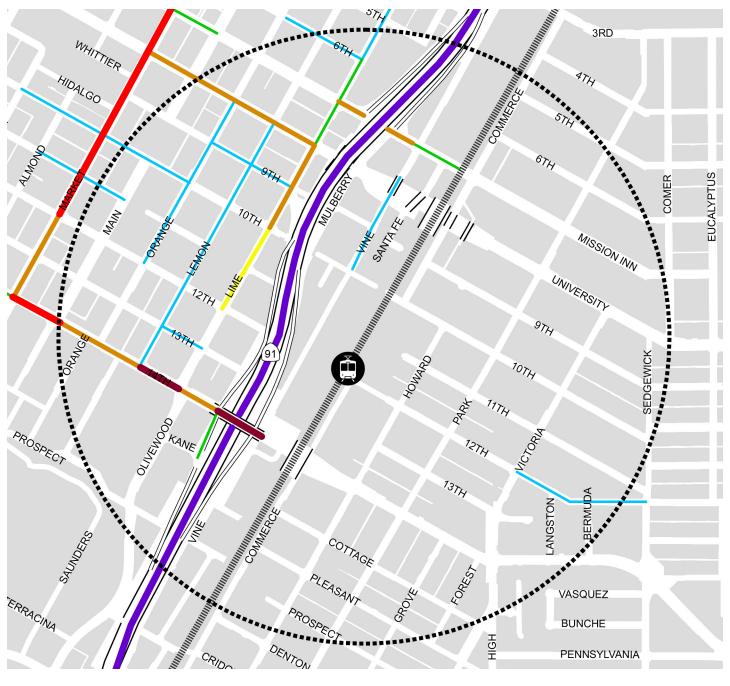
Vehicle - Bicycle / Pedestrian Collisions

Collision concentrations:

- 14th
- University
- Mission Inn
- 14th / Victoria

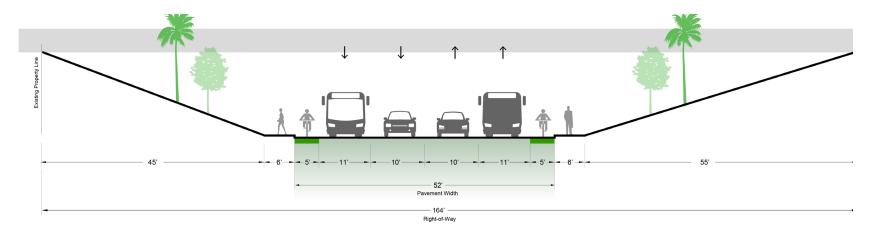
Section A - A'

- 4 travel lanes
- Bus corridor
- On-street bicycle lanes
- Narrow sidewalks
- Additional turn lanes at intersections and freeway access points
- Depressed between Mulberry Street and Park Avenue

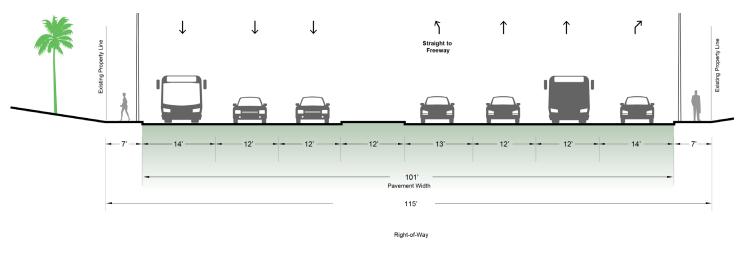
Section A - A'

- 4 travel lanes
- Bus corridor
- On-street bicycle lanes
- Narrow sidewalks
- Additional turn lanes at intersections and freeway access points

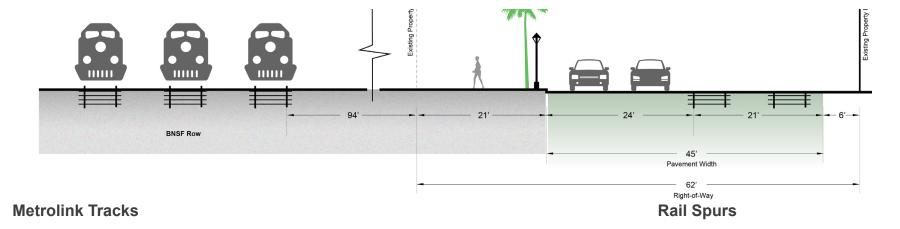
Section A - A'

- Utilization of rail spurs
- Use of Metrolink ROW

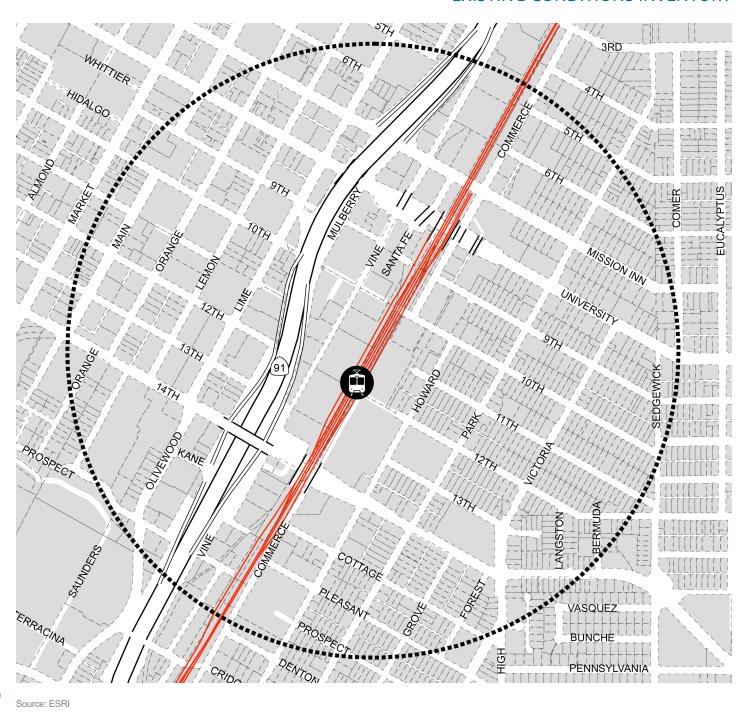
Rail Lines and Truck Routes

- No specific truck routes identified in General Plan
- SR-91 and access points to SR-91 mentioned as truck circulation routes

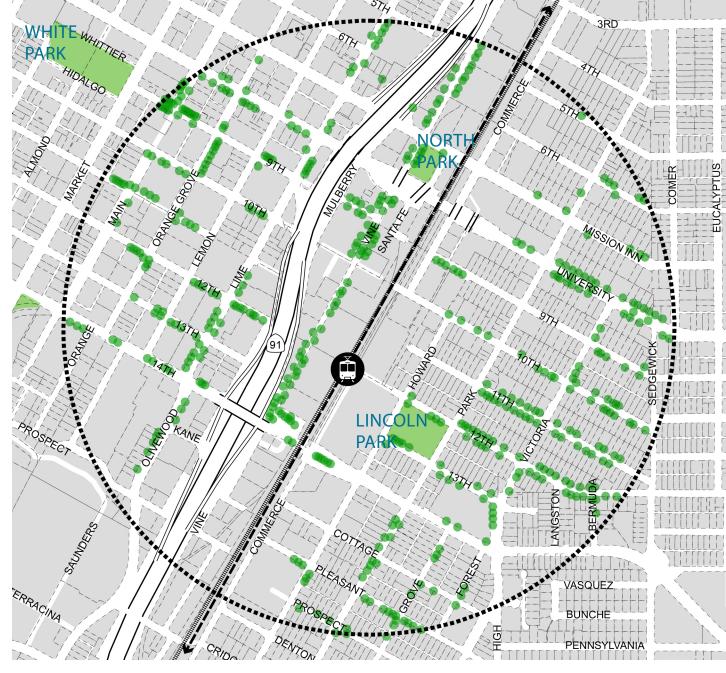
Open Space and Street Trees

Two open spaces within the 1/2 mile area

Street tree coverage concentration:

- Vine Street
- East of Park Avenue
- Downtown Riverside
- Condition, size, age, and species of street trees varies considerably
